Evaluation Report 98

John Deere Model 510 Round Baler

JOHN DEERE MODEL 510 ROUND BALER

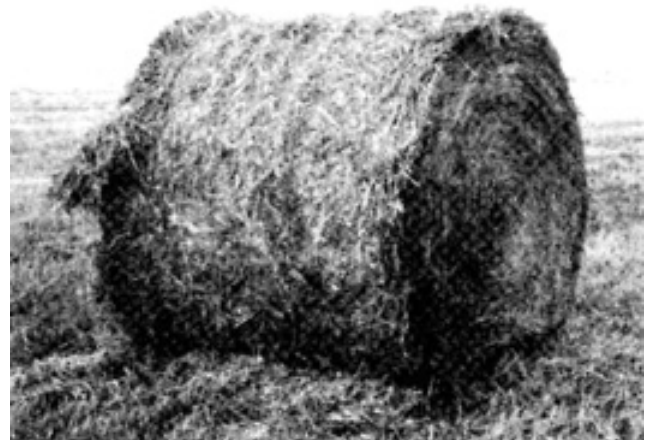
Bale Quality: The John Deere 510 produced firm, durable bales (FIGURE 2) with flat ends, uniform density and uniform diameter. Bales averaged 1.6 m (63 in) in length and 1.8 m (71 in) in diameter. Average hay bales weighed from 550 to 1050 kg (1213 to 2315 lb) with an average density of 215 kg/m³ (13.4 lb/ft³).

FIGURE 2. Typical Hay or Straw Bale.

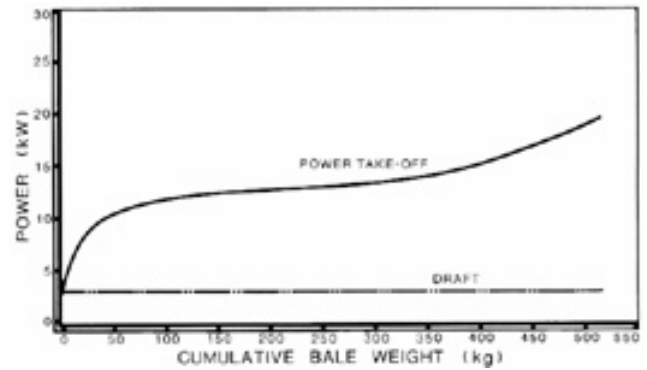
Power Requirements: FIGURE 4 shows the power take-off and drawbar input for the John Deere 510 in alfalfa. The power input is plotted against bale weight to show the power requirements as a bale is being formed. Power take-off input varied from 3 kW (4 hp) at no load to a maximum of 20 kW (27 hp) in alfalfa and 18 kW (24 hp) in barley straw. Drawbar requirements at 7 km/h (5.5 mph) were 3 kW (4 hp).

Although maximum power requirements did not exceed 23 kW (31 hp), additional power was needed to suit field conditions. In soft, hilly fields a 75 kW (100 hp) tractor was needed to fully utilize baler capacity.

FIGURE 4. Power Consumption During Bale Formation.

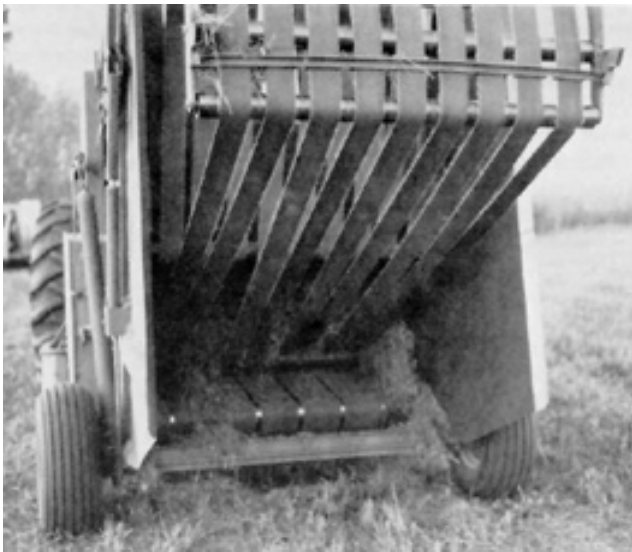
During baling, fine hay accumulated between the bale forming belts (FIGURE 6). When discharging the bale, this hay usually fell on the rear gate latch and sometimes prevented the latch from locking when the gate was closed. If the latch was not locked, the rear gate opened during baling, preventing proper bale formation. Modification to the rear gate latch to eliminate locking problems is recommended.

FIGURE 6. Hay Accumulation Between Belts.

1. Modifications to eliminate malfunction of the gate latch due to hay accumulation on the latch mechanism.
2. Modifications to the twine wrapping system to provide a uniform speed of travel of the twine tube across the bale face.
3. Modifications to improve feeding in long coarse-stemmed crops.
4. Modifications to reduce bale forming belt failure while discharging heavy bales.

1. An indicator is provided for visual monitoring of the latch function. Provided the operator always makes certain the indicator is in the locked position while making a bale, accumulation of hay in this area will not affect machine function. Because of this, no modification program is presently being contemplated.

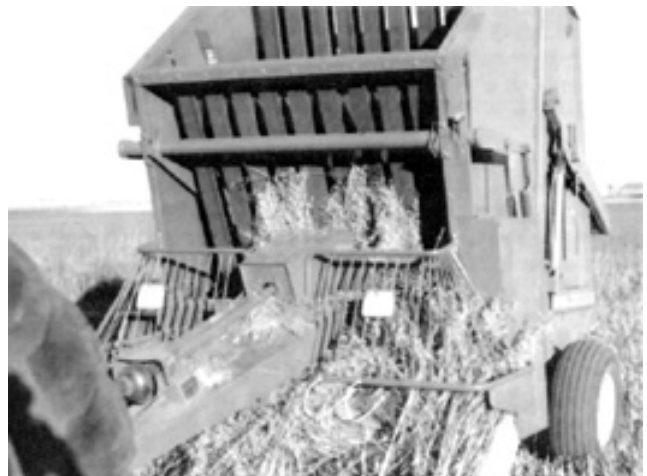
Feeding: Feeding was positive and aggressive in nearly all crops with only infrequent plugging. One exception was in long, coarse-stemmed hay, such as sweet clover. In such crops, stalks often fed up the front of the forming belts (FIGURE 7) rather than through the compression rollers, causing plugging. Modifications are recommended to reduce feeding problems in long, coarse-stemmed hay.

FIGURE 7. Plugging in Long Coarse-Stemmed Hay.

3. Feeding of coarse stem materials can be improved by adding more pickup compression bars. It is also beneficial to raise the pickup as high as is possible to still pick up all the crop. Conditioning the crop improves not only feeding, but also bale density and appearance and improves acceptance as an animal feed.
